# UNDERWATER BRIDGE INSPECTION REPORT

STRUCTURE NO. 23513

ROOT RIVER

MINNESOTA DEPARTMENT OF TRANSPORTATION  
UNDERWATER BRIDGE INSPECTION

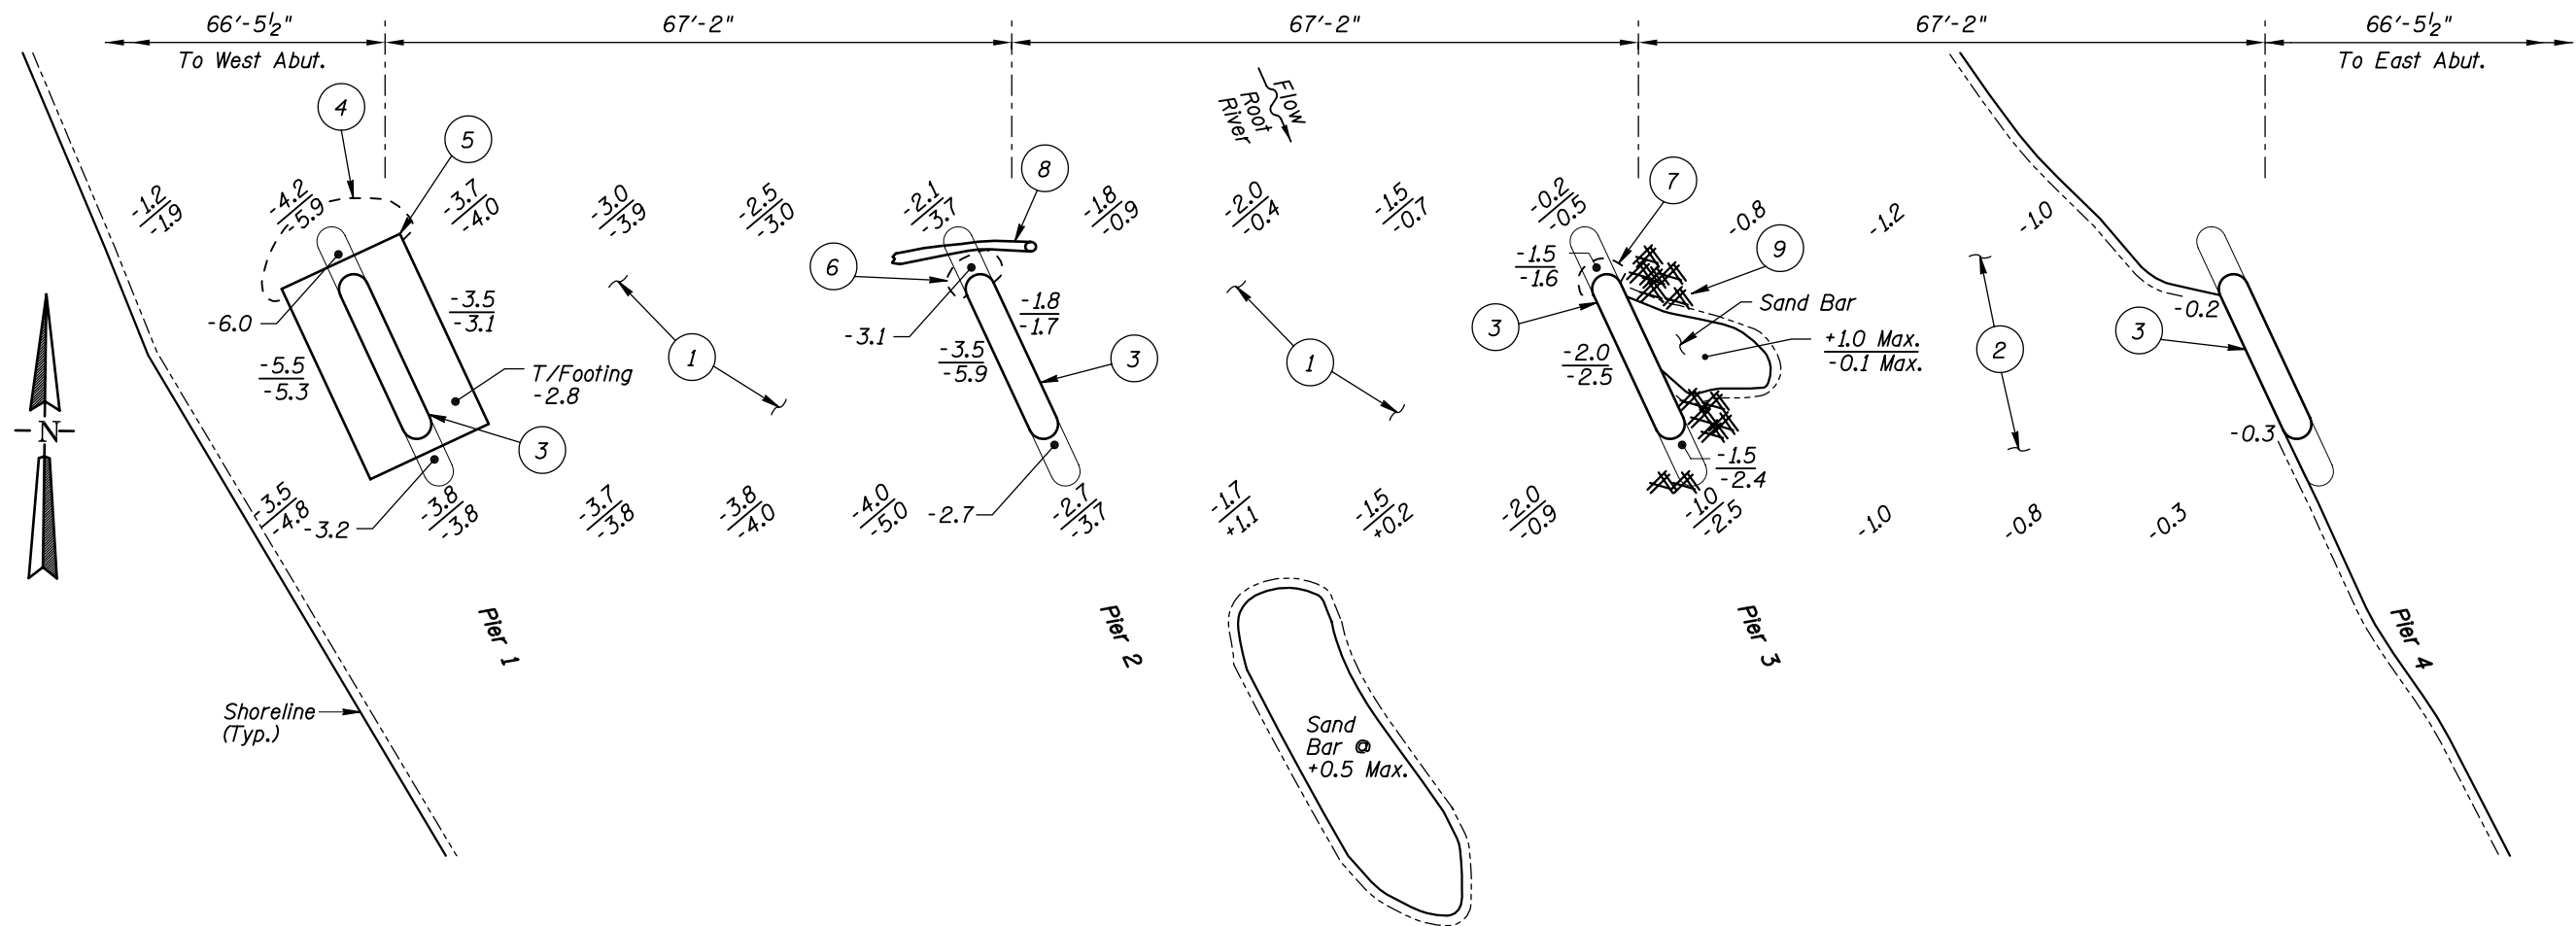
**SOUNDING PLAN**

- 1 The channel bottom material consisted of firm silty sand with gravel and scattered 5 inch diameter cobbles with maximum probe rod penetrations of 2 to 4 inches.

- 2 The channel bottom material consisted of soft silt over gravel with a maximum probe rod penetration of 6 inches.
- 3 The concrete of the piers was in good and sound condition with no significant deterioration.

- 4 A scour depression, 2 foot deep and 6 feet in radius, was observed at the upstream nose of the pier.
- 5 The top of the footing was exposed around the entire pier with up to 3.2 feet of vertical footing exposure at the upstream end of the pier with no undermining observed.

- 6 A scour depression, 1 foot deep and 3 feet in radius, was observed at the upstream nose of the pier.
- 7 A scour depression, 6 inches deep and 2 feet in radius, was observed at the upstream nose of the pier.

- 8 An 18 inch diameter log was observed across the upstream nose of the pier.
- 9 A light accumulation of branchy timber debris was observed along the east face and downstream nose of Pier 3.

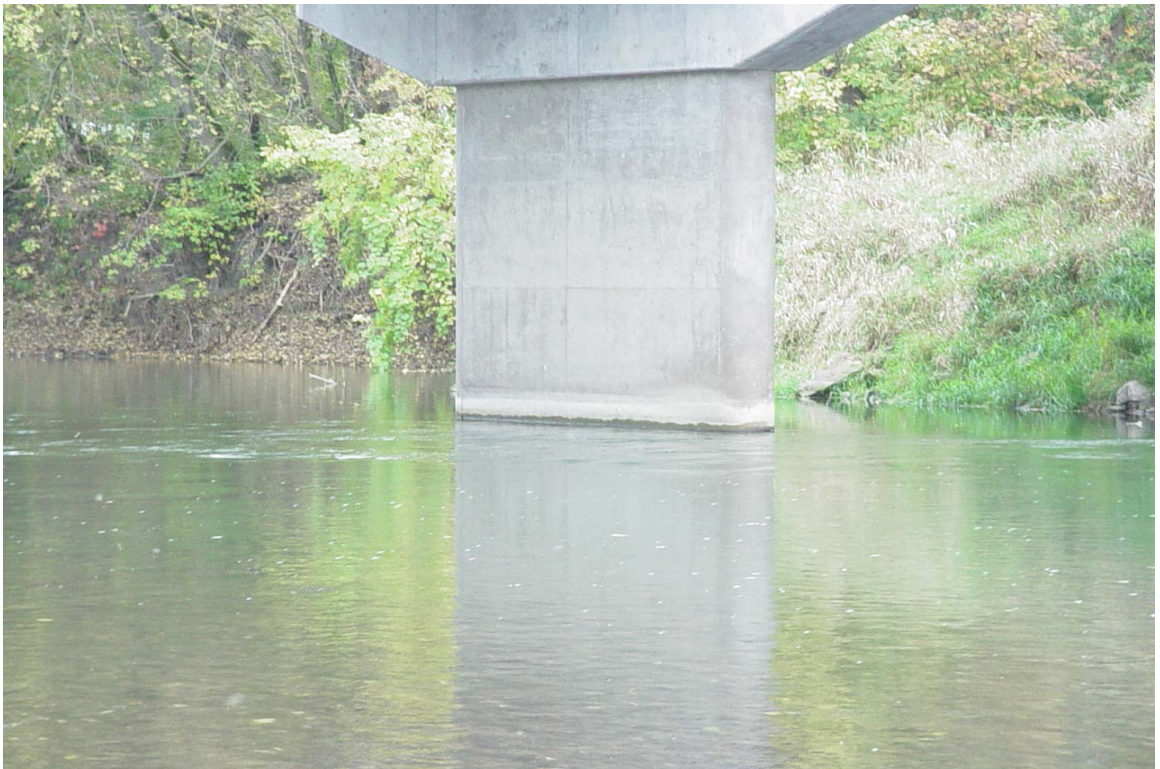
Photograph 2. View of Pier 1, Looking Southwest.

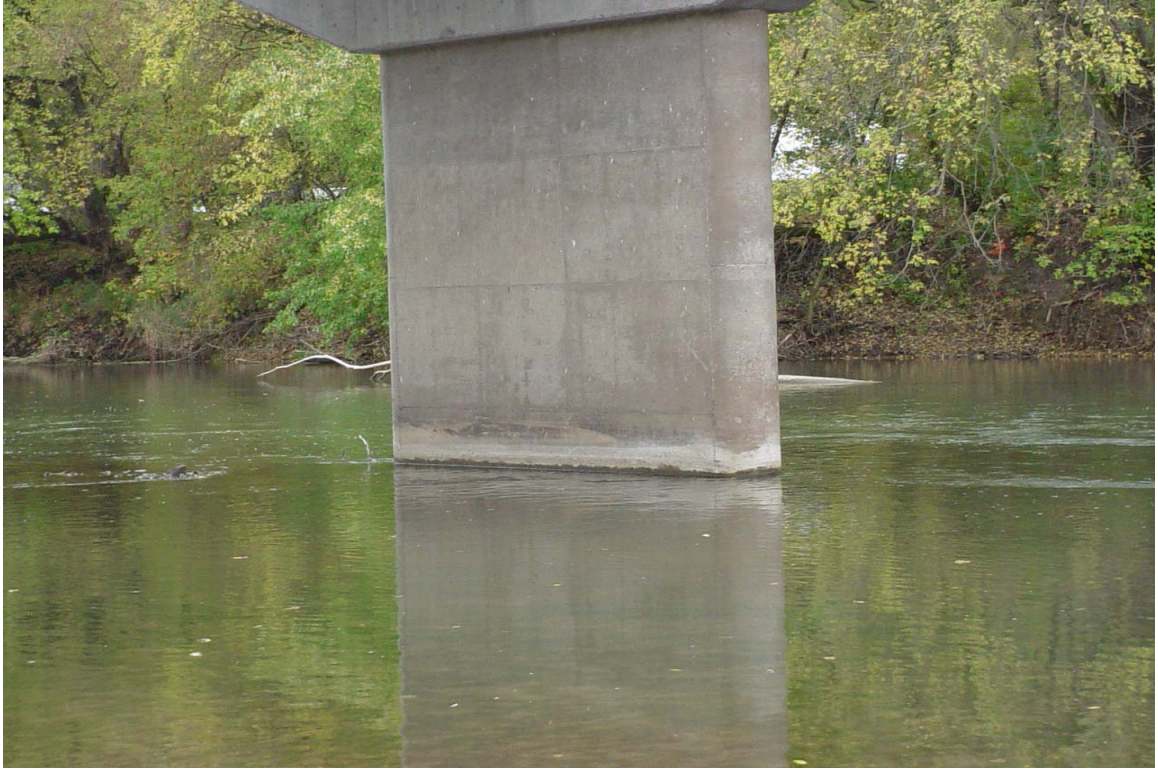
Photograph 3. View of Pier 2, Looking Southwest.

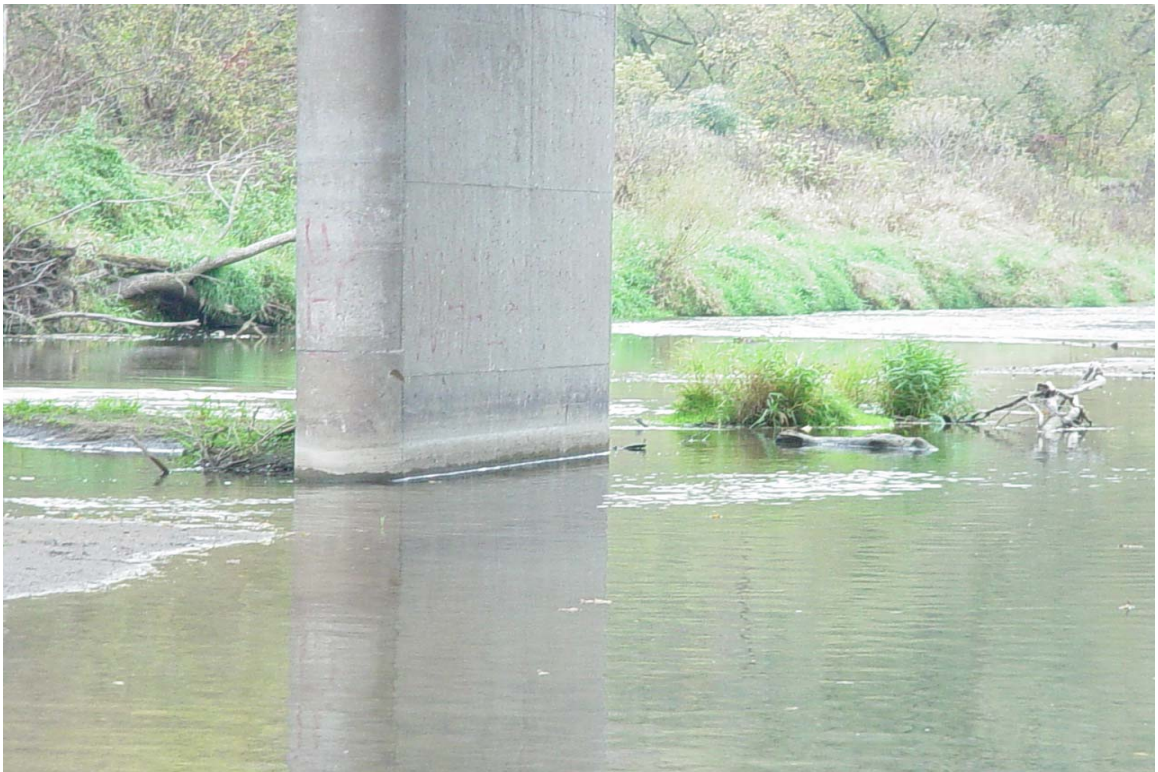
Photograph 4. View of Pier 3, Looking Southeast.

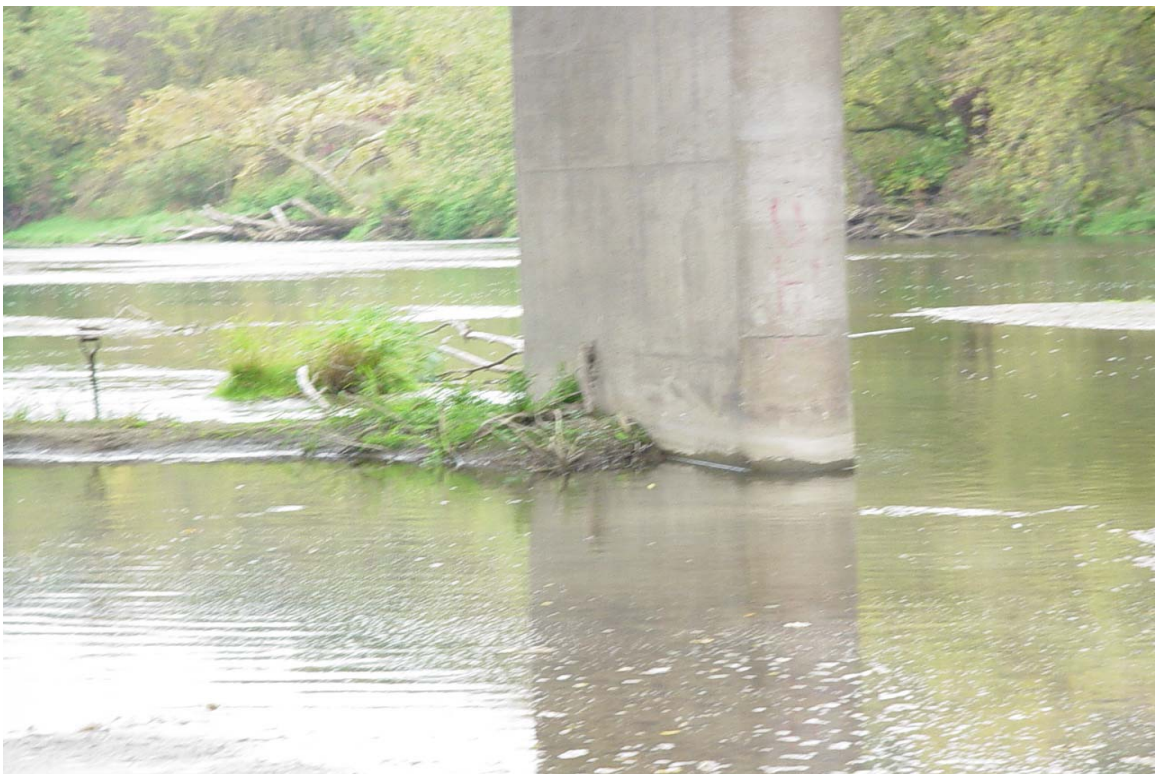
Photograph 6. View of Timber Debris at Pier 3, Looking Southwest.

Monitor the timber debris at Piers 2 and 3, and if found to be increasing in the future, removal operations may become warranted.
